HARTZELL PROPELLER INC.

SERVICE BULLETIN

Propellers - Composite Blade Inspection

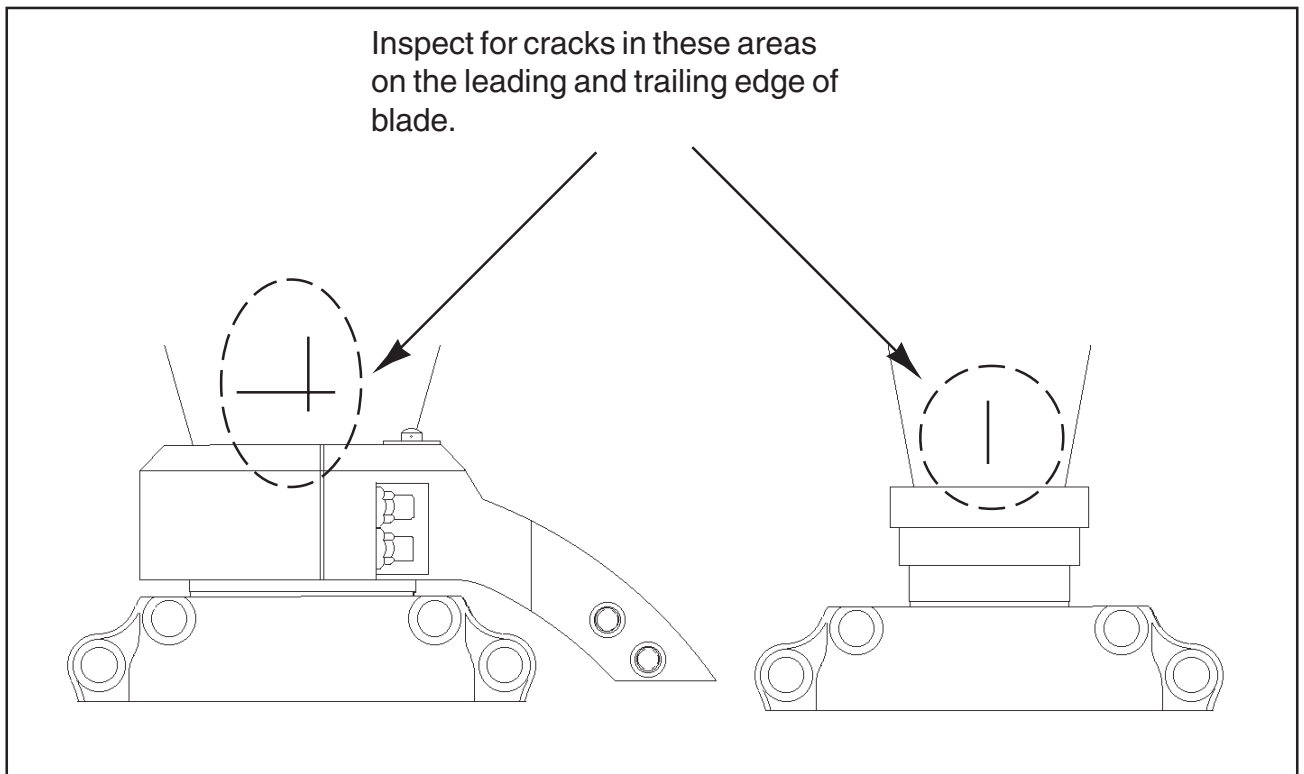
Figure 1

(2) Composite blades in a propeller installed on an undampened or modified Lycoming (AE)IO-360 engine may exhibit stress cracking or other vibration induced damage in the shank and/or counterweight area of the blade.

- (1) Remove spinner in accordance with the Propeller Owner's Manual No. 145 (ATA 61-00-45).
- (2) Inspect (on wing) for cracks in the blade shank area as shown in Figure 1. If the blade has counterweights, inspect around the blade shank and counterweight assembly.
- (3) If no cracks are visible, reinstall spinner and make a log book entry indicating compliance with the inspection specified in this Service Bulletin and indicate when the next inspection is due.
- (4) If a crack is present:
 - (a) Disassemble the propeller in accordance with Hartzell Manual 113B.
 - (b) Retire cracked blade(s). Notify Hartzell Propeller Product Support.
 - (c) Reassemble the propeller in accordance with Hartzell Manual 113B.
