HARTZELL PROPELLER INC.

SERVICE BULLETIN 165E
CODE: C

Inspection for Cracks in Certain Three Blade "Y" Shank Aluminum Hubs

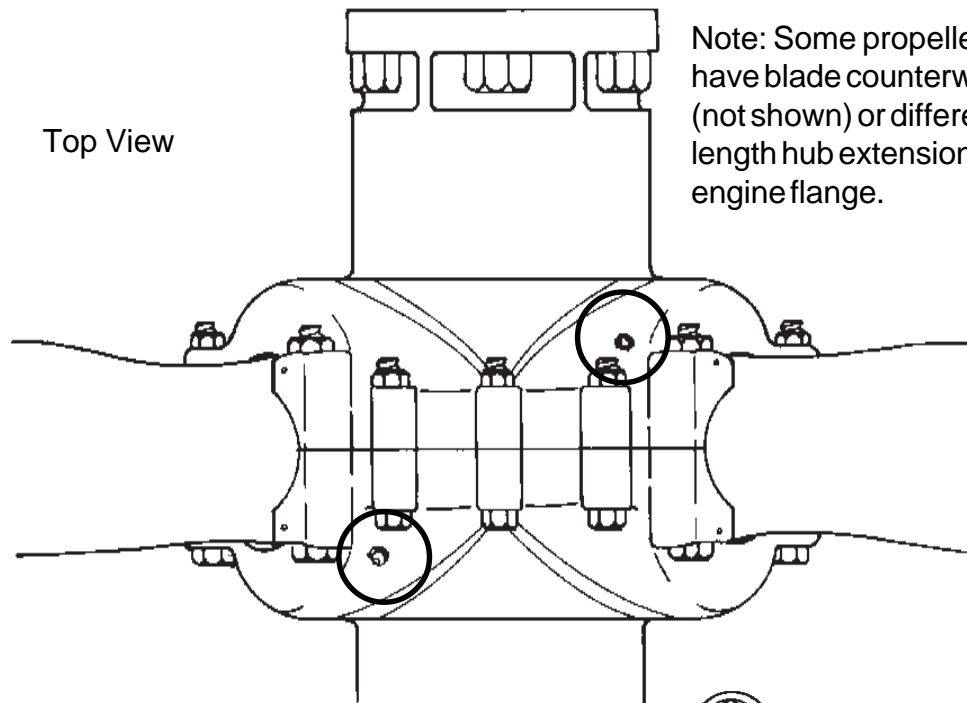
Top View

3. Use 10X magnifying glass and light source to perform careful visual inspection of the hub for hairline cracks in the general vicinity of blade retention bearings, but primarily inspect the grease fitting areas as shown in Figure 1. Perform inspections with grease fittings installed.

Circled areas encompass grease fittings to be inspected at two points on each blade socket

- 2) Scan probe gradually around each of the six grease fittings on the propeller hub. See Figure 1, scan probe in a manner to cross typical crack indications (rather than scanning in strokes that may be parallel to typical crack indications). The center of the probe tip must pass within 1/4 inch of the grease fittings and outward from the fitting as far as practical (up to 2 inches). The initial scanning around the grease fitting should consist of a circle with the probe as close to the grease fitting hole as possible. Perform subsequent scans of concentric circles around the grease fitting with no more than 1/10 inch spacing between circles.

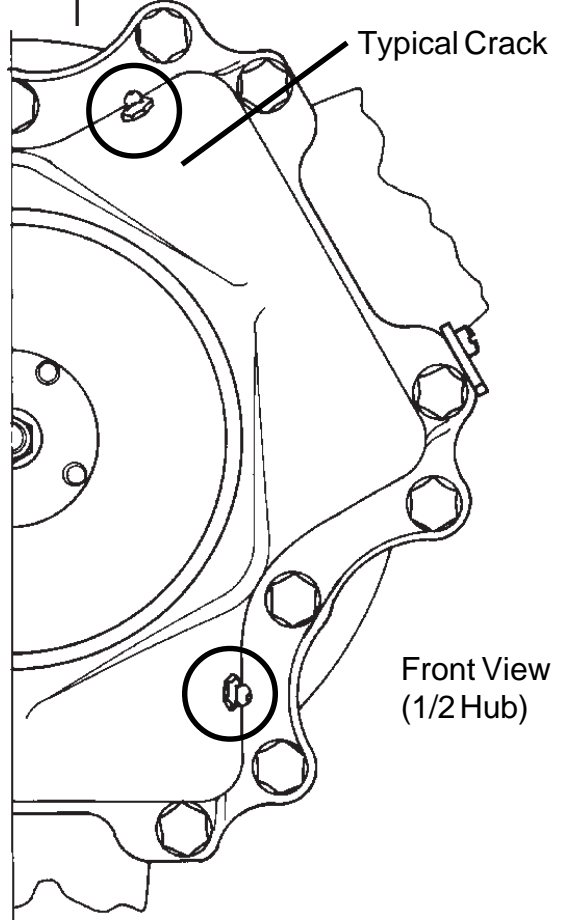
Front View (1/2 Hub)

In Hartzell three blade "compact" aluminum hub propellers, cracks typically originate in the threads of a grease fitting hole on the inside of the hub. As the cracks propagate around the blade arm of the hub, their progression accelerates and results in failure of one hub half. Several incidents have continued to progress to blade separation.

NOTE: Typically, cracks begin at the grease fitting and propagate perpendicular to blade around the blade arm barrel. Cracks may initiate on either hub half from any of the six (6) grease fittings.

Typical Crack

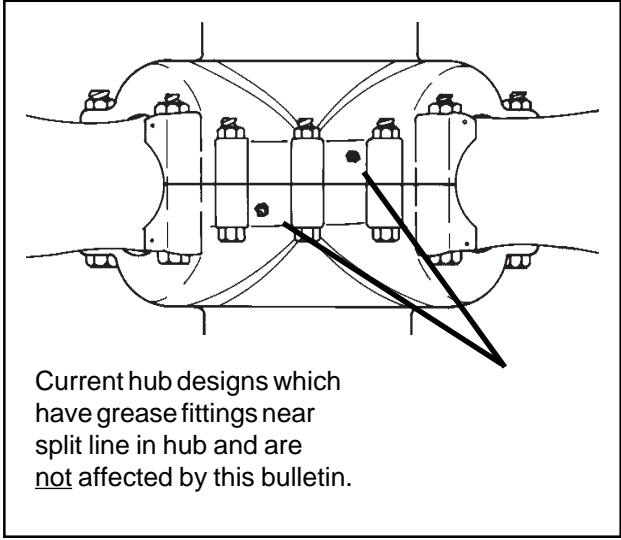
NOTE: During 1983, a hub design change relocated the grease fitting holes near the hub parting line (see Figure 1). The earlier-design hubs are listed as affected serial numbers, however, there may be a few hubs listed that are of the later type. Any hub found to be of the current configuration does not require compliance with this Bulletin. Any hub with the old configuration requires compliance.

Current hub designs which have grease fittings near split line in hub and are not affected by this bulletin.
